SUBJECT: Report No. 06-04A, "Transportability Testing of the Joint Modular Intermodal Platform (JMIP)", TP-94-01, "Transportability Testing Procedures"

**FINAL REPORT
NOVEMBER 2006**

REPORT NO. 06-04A

**TRANSPORTABILITY TESTING OF THE JOINT MODULAR
INTERMODAL PLATFORM (JMIP)
TP-94-01,
“TRANSPORTABILITY TESTING PROCEDURES”**

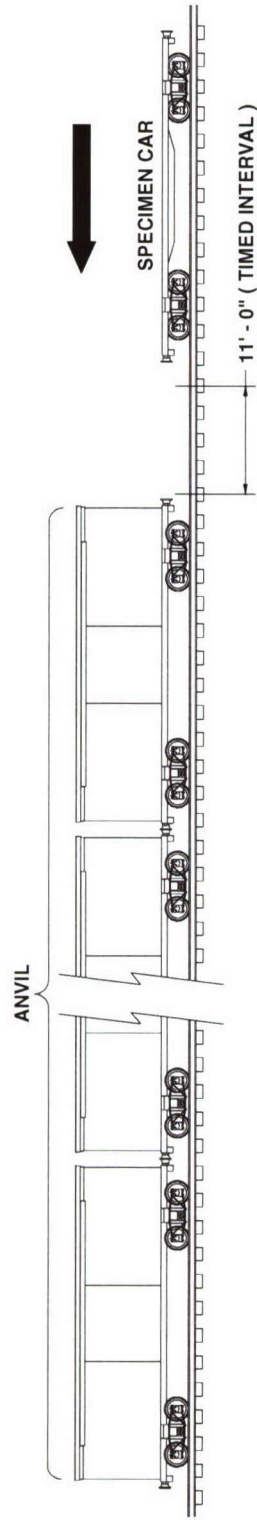
ASSOCIATION OF AMERICAN RAILROADS (AAR)

STANDARD TEST PLAN

4 BUFFER CARS (ANVIL)
WITH DRAFT GEAR
COMPRESSED AND AIR BRAKES IN A SET
POSITION

ANVIL CAR TOTAL WT. 250,000 LBS (APPROX)

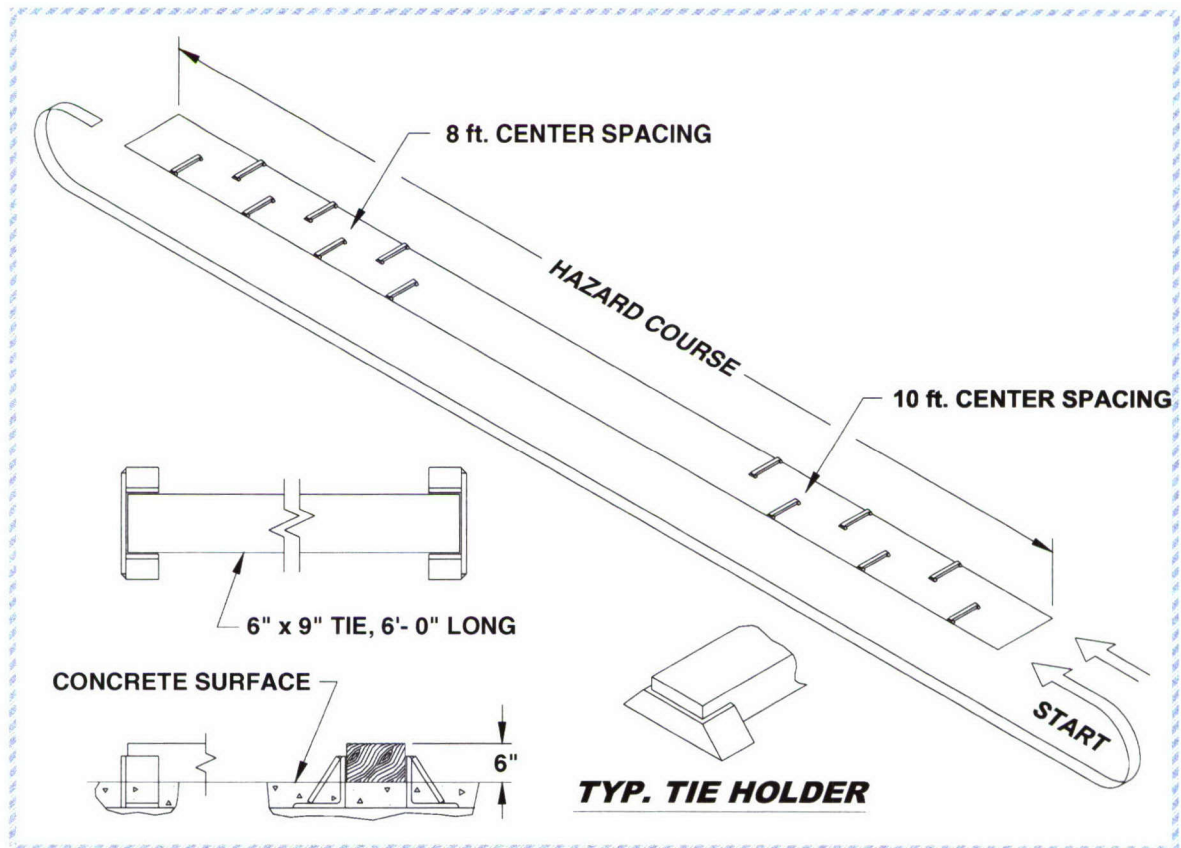
Figure 2. Hazard Course Sketch

1. HAZARD COURSE. The test load or vehicle will be transported over the 200-foot-long segment of concrete-paved road consisting of two series of railroad ties projecting 6 inches above the level of the road surface. The hazard course will be traversed two times (see Figure 2).

- a. The first series of 6 ties are spaced on 10-foot centers and alternately positioned on opposite sides of the road centerline for a distance of 50 feet.
- b. Following the first series of ties, a paved roadway of 75 feet separates the first and second series of railroad ties.

d. The test load is driven across the hazard course at speeds that will produce the most violent vertical and side-to-side rolling reaction obtainable in traversing the hazard course (approximately 5 mph).

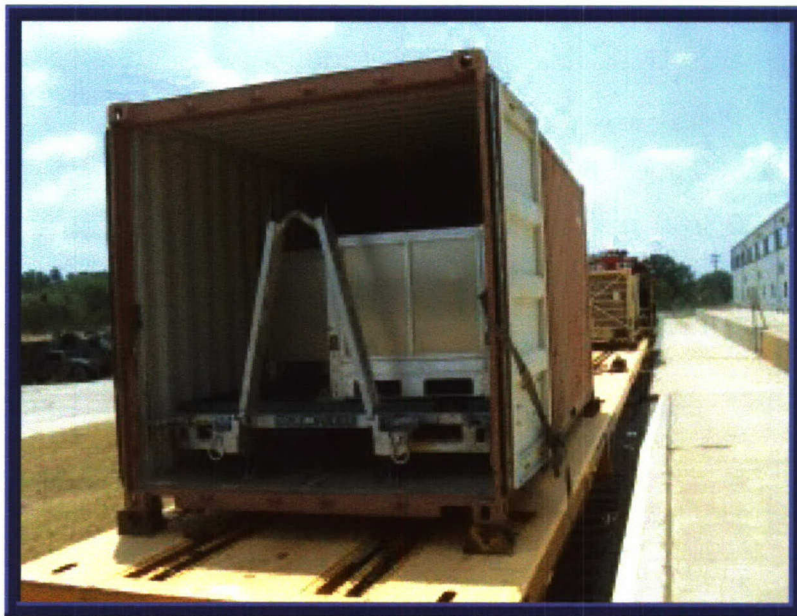
Photo 1. Rail Impact Testing of the JMIP (Prior to Testing)

Description	Weight
Flatcar Number: DODX 42353	85,000 lbs.
Intermodal Container with JMIP	20,390 lbs.
M1 Flatrack with MLRS Pods	28,265 lbs.
Total Specimen Wt.	133,655 lbs.
Buffer Car (four cars)	257,900 lbs.

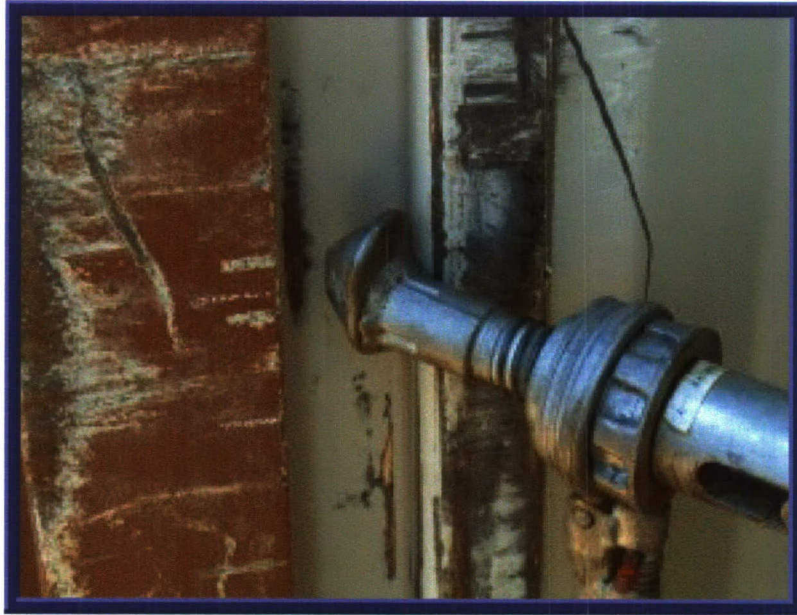
Photo 2. Movement of Corner Lock in Shoring Slot.

1. Figure 5 lists the average speeds of the specimen car immediately prior to impact with the anvil. Impact #5 is the reverse impact.
2. Impact #3 was determined to be a “no test” due to the insufficient velocity at impact. The test was repeated.
3. Following Impact #1 the JMIP moved forward 0.25-0.5 inches in the direction of impact. The JMIP corner locks were now tight in the container shoring slots.
4. Following Impact #5 the JMIP moved 1.5 inches in the direction of impact. The rubber bumpers at the aft end of the JMIP compressed on impact and allowed the JMIP to move. The JMIP corner locks moved and were no longer properly engaging the container shoring slot. (See Photos 2 and 3).

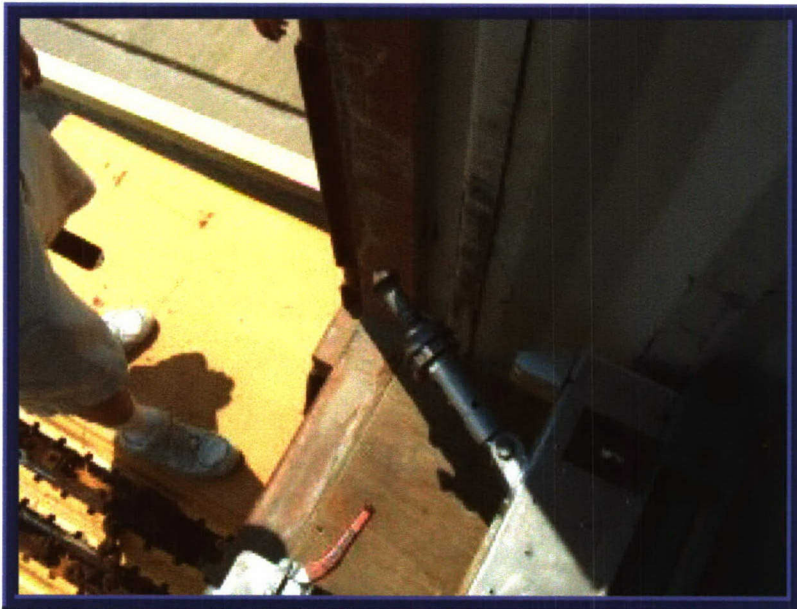
Photo 3. Disengaged Corner Lock.

8. The plate and corner locking mechanisms are susceptible to damage when the JMIP is moved using a forklift at the A-frame end.
9. During rail impact testing, the corner locks disengaged from the shoring slots and did not prevent the JMIP from excessively moving in the longitudinal direction.

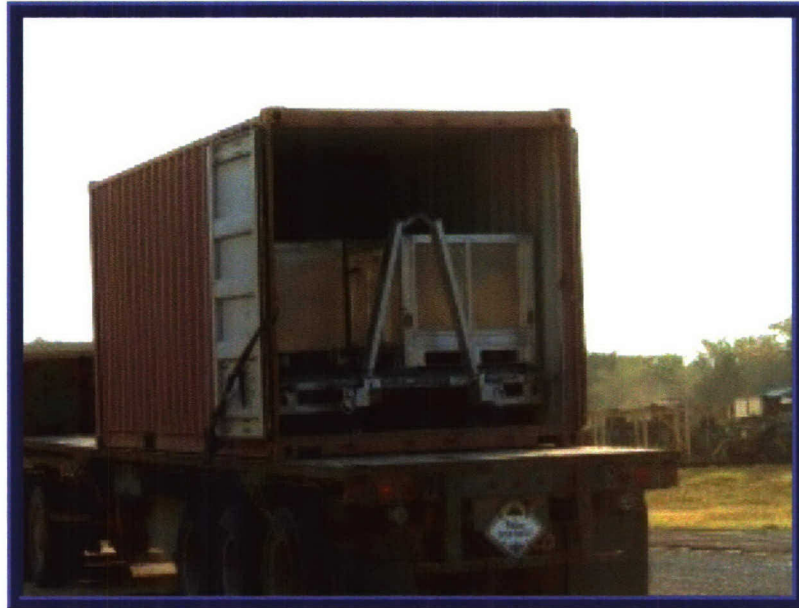
Photo 4. Hazard Course Testing of the SEA BOX JMIP

Pass No.	Elapsed Time	Avg. Velocity (mph)
1	24 Seconds	6
2	24 Seconds	6

1. Figure 6 lists the average speeds of the test load through the Hazard Course.
2. Inspection following Pass #1 revealed that the JMIP had moved toward the container door 0.25 inches.
3. Inspection did not reveal any damage to the JMIP.

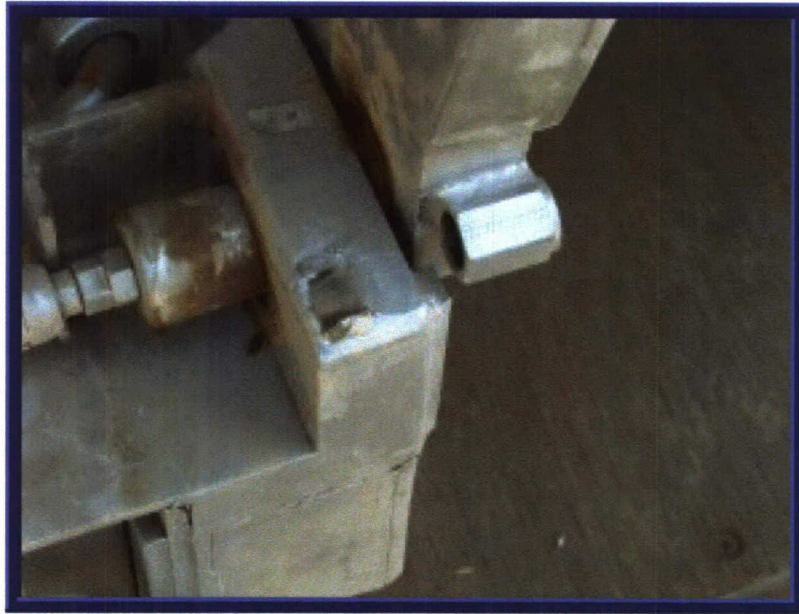
Photo 5. Location of Failed Weld and Missing Bolt.

12. The weld around the nut holding the A-frame in the container transport position failed and the nut and bolt detached from the JMIP.
13. One of the pins that hold the A-frame in the PLS transport position disengaged when transported over the washboard course. The engagement handle (red handle) was in the open position following the completion of the course.

1. Figure 7 lists the average speeds of the test load through the Hazard Course.
2. Inspection following Pass #3 revealed that the weld around one of the nuts that restrained the bolts holding the A-frame in the container transport position cracked.
3. Inspection following Pass #4 revealed that the weld around the nut failed and the bolt holding the A-frame in the container transport position disengaged and fell off of the JMIP. (See Photo 5).
4. The corner locks moved vertically during each pass of the hazard course. The corner locks remained engaged in the shoring slots.

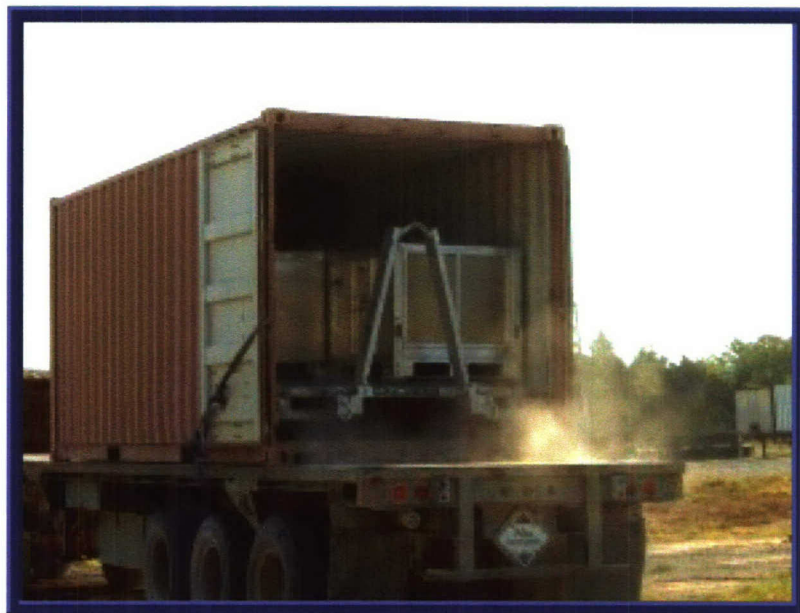
Photo 6. Washboard Course Testing JMIP.

Inspection following the Washboard Course revealed no additional damage or movement to the JMIP.

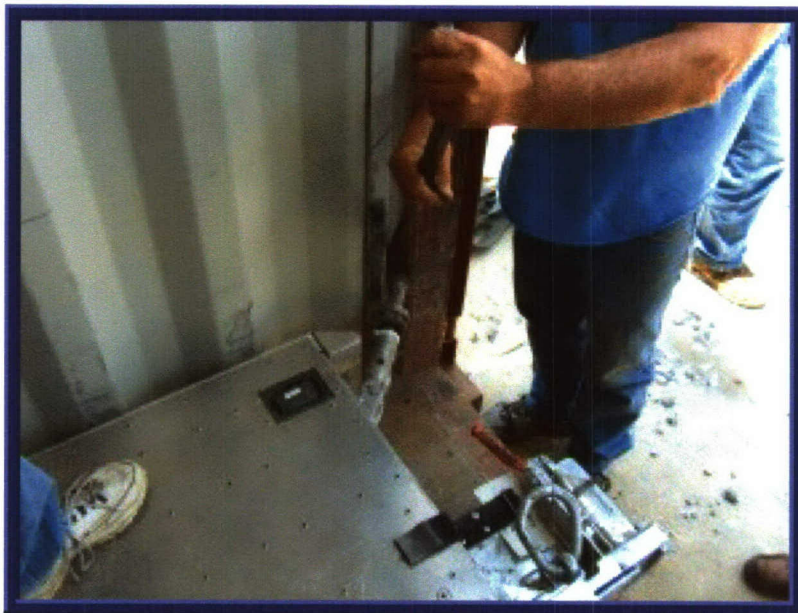
Photo 7. Disengagement of Corner Lock of JMIP with Tools.

10. The corner lock on the PLS driver's side would not properly retract at the completion of testing. The lock had to be retracted using a hammer.
11. Final inspection of the container shoring slot showed that the point load from the corner locks caused permanent deformation and weld failure.

1. Following completion of the STS testing one of the JMIP corner locks would not disengage properly. A hammer and pry bar had to be used to disengage the corner lock from the shoring slot.
2. Final inspection revealed that the end of the JMIP corner lock had permanently deformed the container shoring slot and damaged the weld.

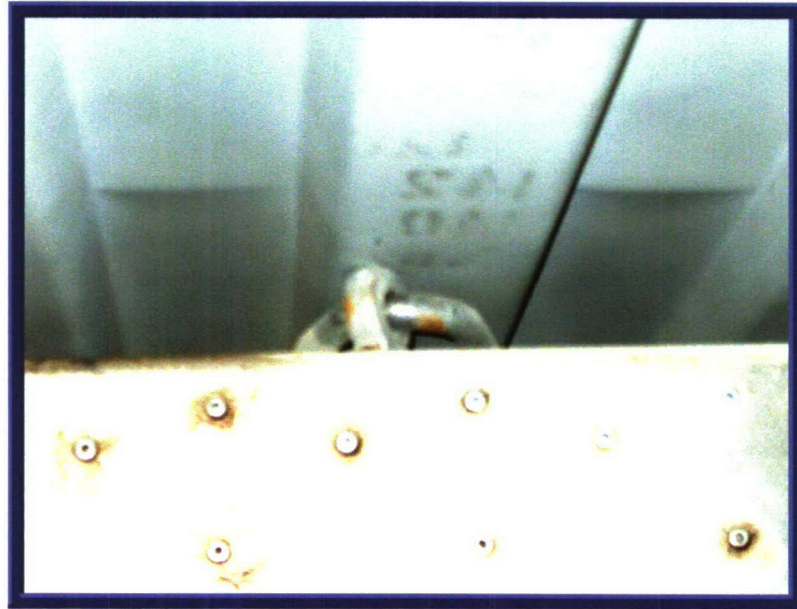
Photo 8. Contact of Tiedowns with Container Wall.

1. When inside the intermodal container, the JMIP A-frame contacts the inside of the container door.
2. The JMIP rear tie-down rings contact the container wall and during testing damaged the container wall. (See Photos 8 and 9).

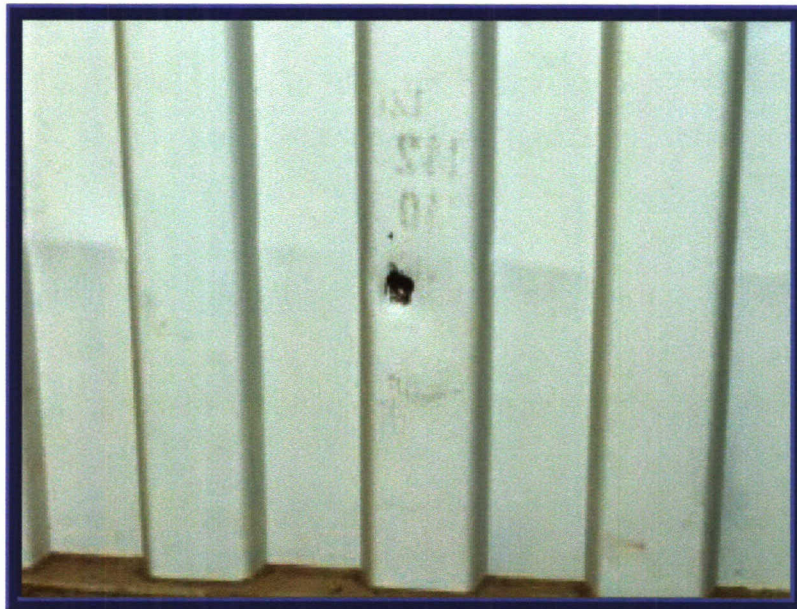
Photo 9. Damage to Container Wall from Rear Tiedowns.

6. When the A-frame is in "Transport Mode" inside the intermodal container, the A-frame contacts the inside of the container door.
7. The rear tie-down rings contact the container wall and during testing the rear tie-down rings damaged the container wall.

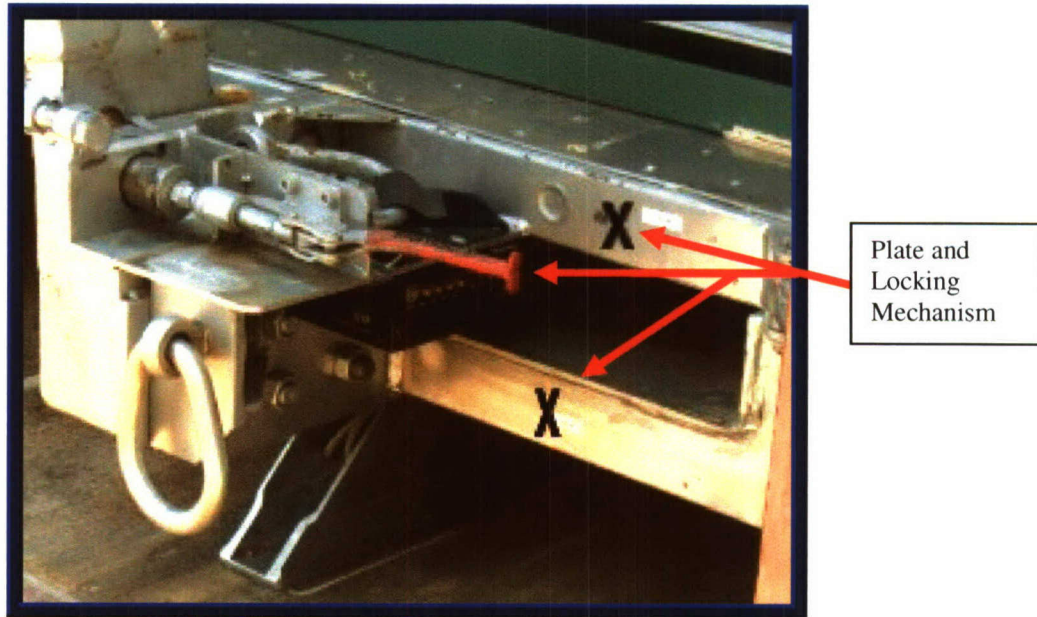
Photo 10. Area of Potential Forklift Damage.

3. The plate and corner locking mechanisms are susceptible to damage when the JMIP is moved using a forklift at the A-frame end. (See Photo 10).

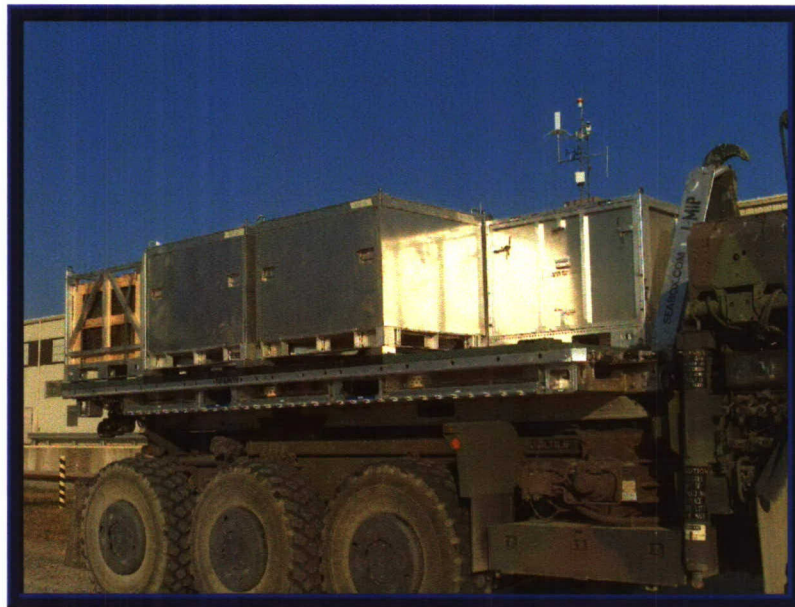
Photo 11. JMIP on the PLS Truck

Note: When on the PLS truck, the rails at the front of the JMIP did not rest on the support (frog feet) of the PLS truck. The base of the JMIP, between the main rails, rested on the PLS load handling system. (See Photo 12).

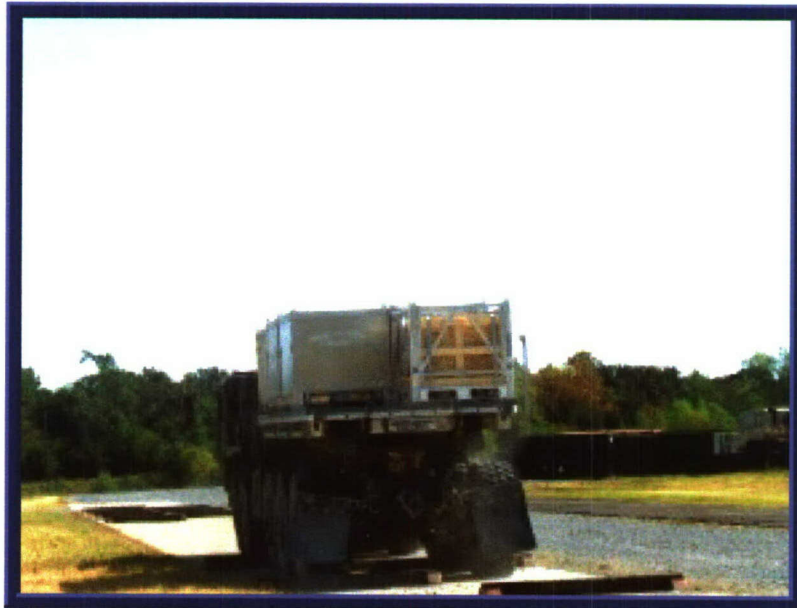
Photo 13. Hazard Course Testing of the JMIP on the PLS Truck

Pass No.	Elapsed Time	Avg. Velocity (mph)
1	20 Seconds	7
2	19 Seconds	7

1. Figure 8 lists the average speeds of the test load through the Hazard Course.
2. Inspection following the completion of Pass #2 revealed that the main rails of the JMIP retracted 0.125-0.25 inches.

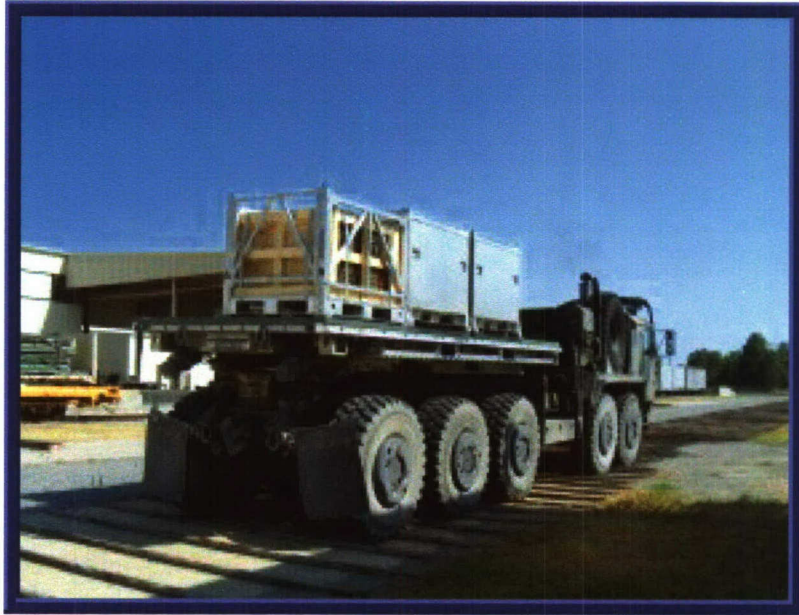
Photo 14. Washboard Course Testing of the JMIP on the PLS Truck.

Inspection following the Washboard Course revealed no damage to JMIP.

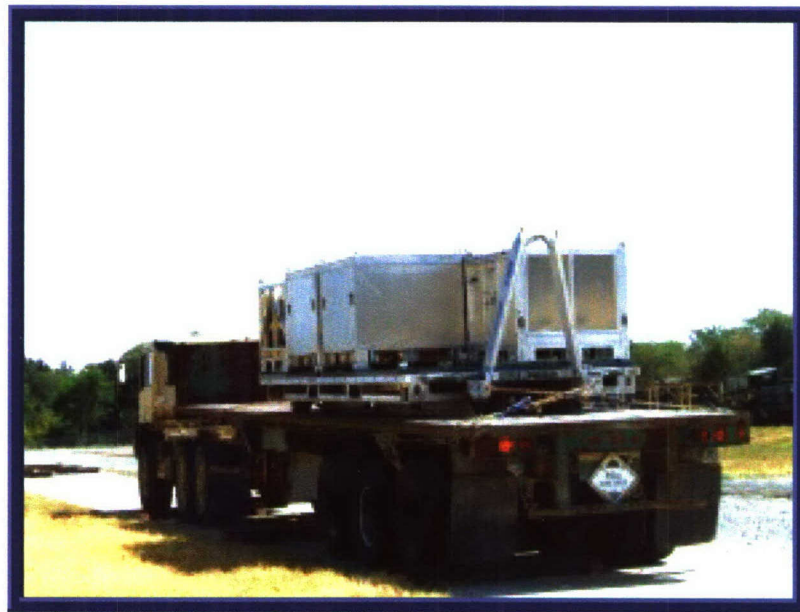
Photo 15. Hazard Course Testing of the JMIP on the M872 Trailer

Pass No.	Elapsed Time	Avg. Velocity (mph)
1	No Time	----
2	24 Seconds	6

1. Figure 11 lists the average speeds of the test load through the Hazard Course. The proper elapsed time was not recorded for Pass #1.
2. Inspection following the Hazard Course revealed no damage or movement to the JMIP.

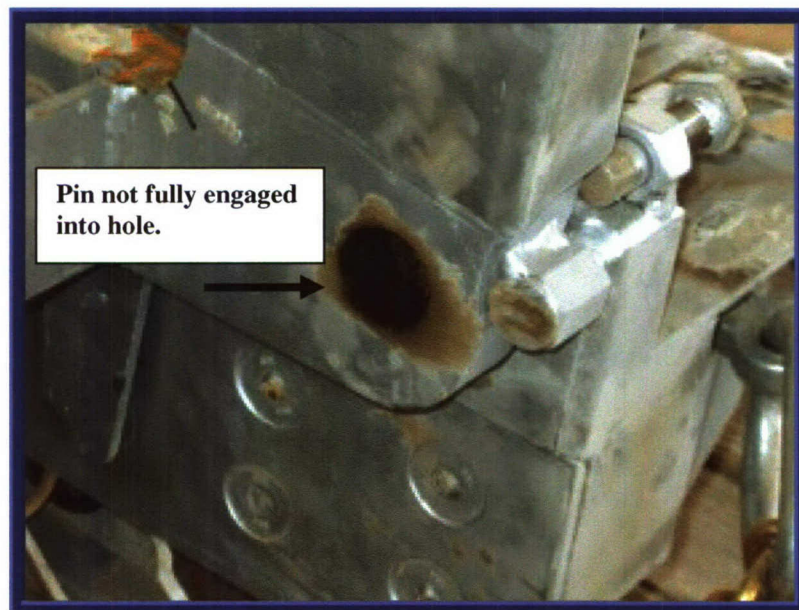
Photo 17. Disengaged A-frame Pin.

1. The A-frame pin and handle disengaged.

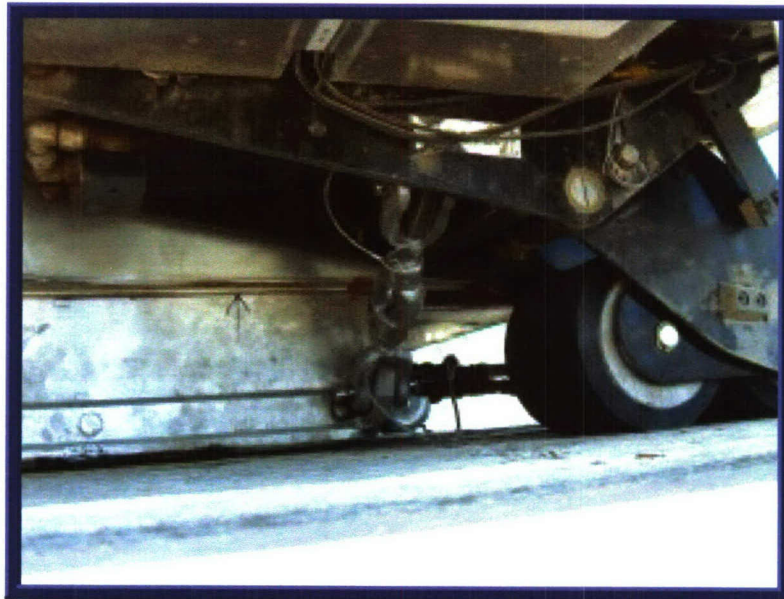
Photo 19. Main Rail not Resting on Trailer Deck.

B. OBSERVATION: The JMIP wheels were not pinned at the proper position. The main rails in the vicinity of the wheels did not rest on the trailer deck.

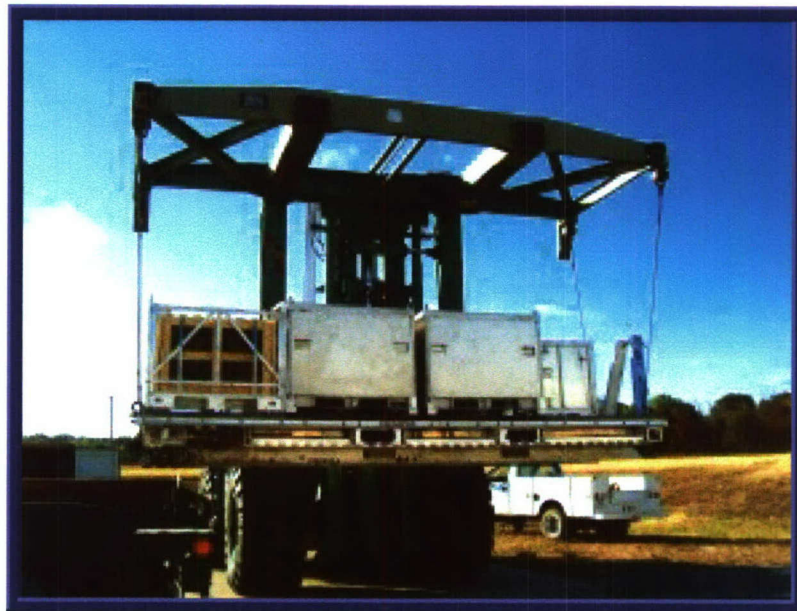
Photo 20. Four-Point Lift of the JMIP.

A. TEST DESCRIPTION. The JMIP was lifted using the Rough Terrain Container Handler and held for 10 minutes. The JMIP was first lifted using a four-point lift and then the test was repeated using a two-point lift.

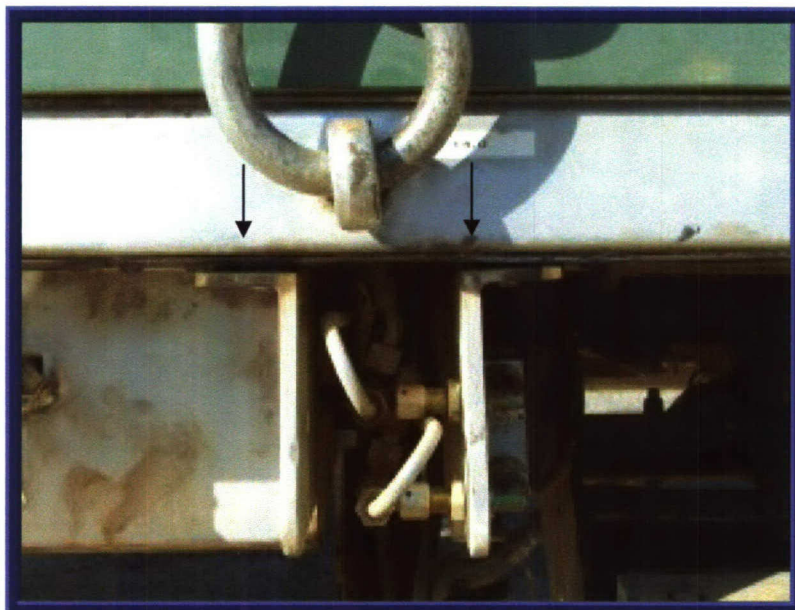
Photo 22. Deflection around the Lifting Rings.

1. During the lifting test, the JMIP main deck bowed.
2. The areas around the lifting rings deflected during the test and caused one rivet to pull loose on the plate at the aft end of the JMIP around the hydraulics.

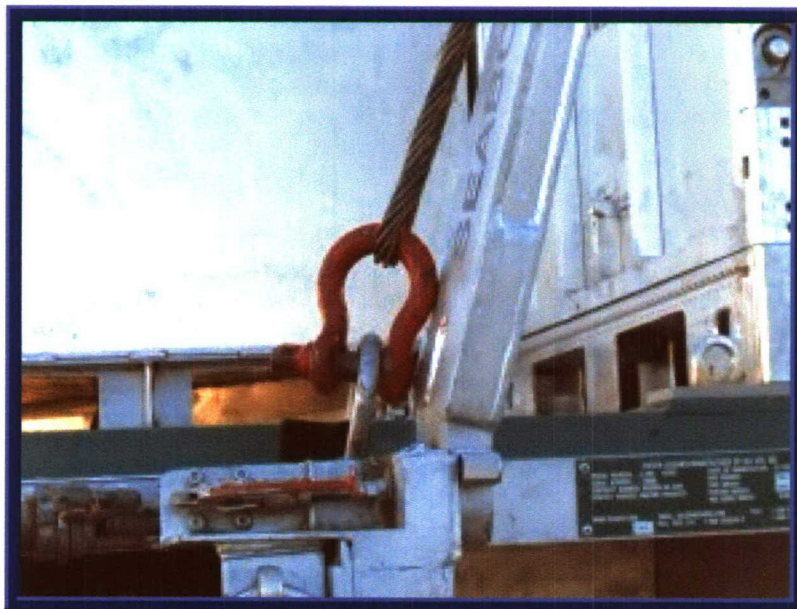
Photo 24. Contact of A-frame During the Lifting Test.

3. During the two-point lift, the shackles and cable contacted the JMIP A-frame.

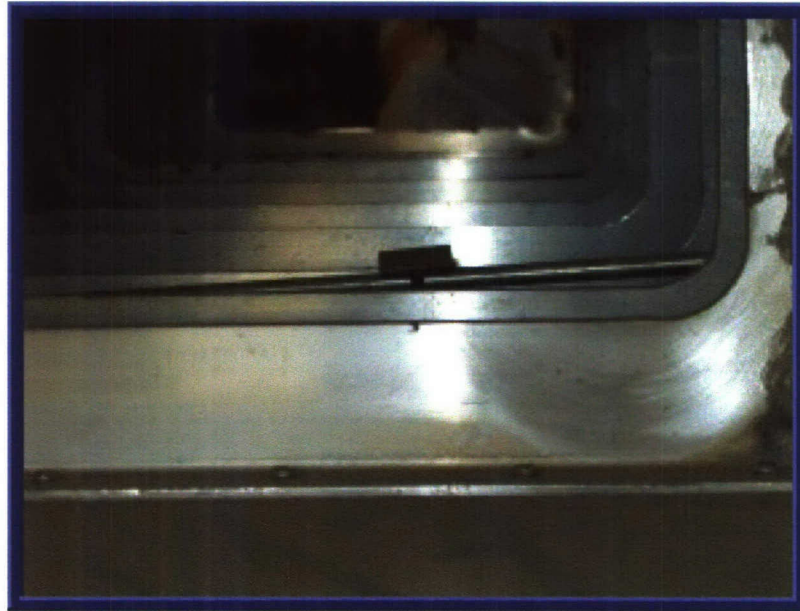
Photo 25. Detached Hydraulic Line Bracket.

4. The bracket holding the hydraulic line detached allowing the hydraulic line to interfere with forklift handling from the side.

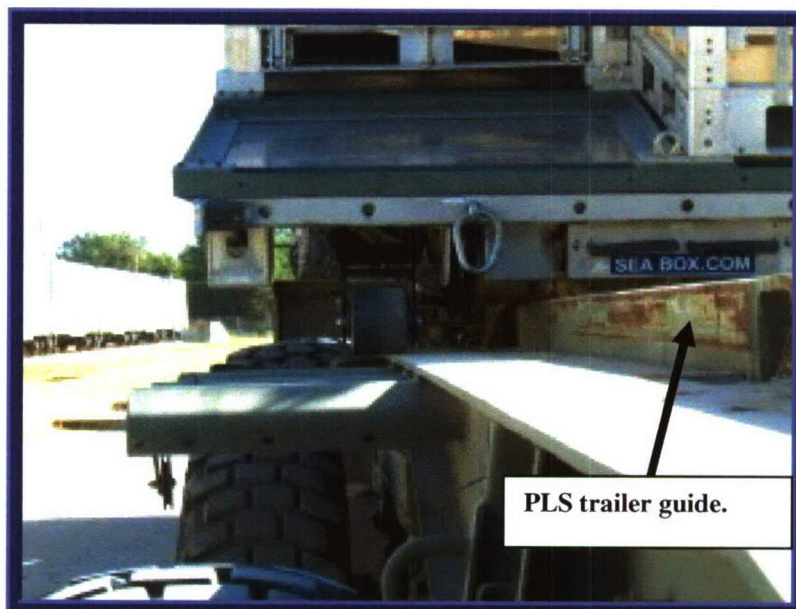
Photo 26. Overhang of the Roller Wheel during Loading on the PLS Trailer.

B. OBSERVATIONS: The JMIP could not be successfully loaded onto the PLS trailer. The rollers on the JMIP are too far outward to stay on the PLS trailer platform during loading. The main rails of the JMIP also are spaced outward enough that the guide on the PLS trailer is ineffective.

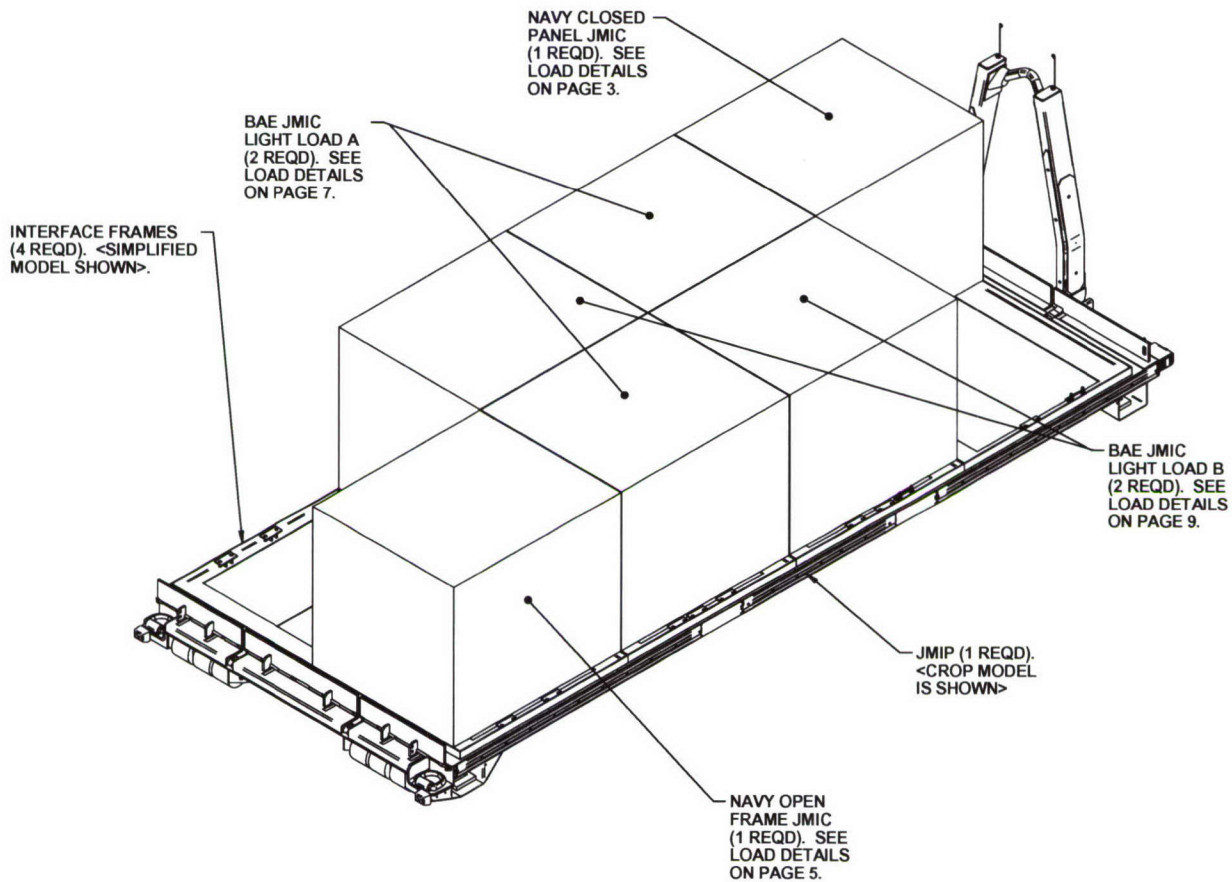
ISOMETRIC VIEW

LOAD AS SHOWN

<u>ITEM</u>	<u>QUANTITY</u>	<u>WEIGHT (APPROX)</u>
NAVY PANEL JMIP - - - 1 - - - - -		2,971 LBS
NAVY FRAME JMIP - - - 1 - - - - -		2,916 LBS
BAE JMIP (4 BOXES) - 2 - - - - -		1,832 LBS
BAE JMIP (8 BOXES) - 2 - - - - -		2,792 LBS
INTERFACE FRAMES - - 4 - - - - -		580 LBS
JMIP - - - - -		3,800 LBS
TOTAL WEIGHT - - - - -		14,891 LBS (APPROX)

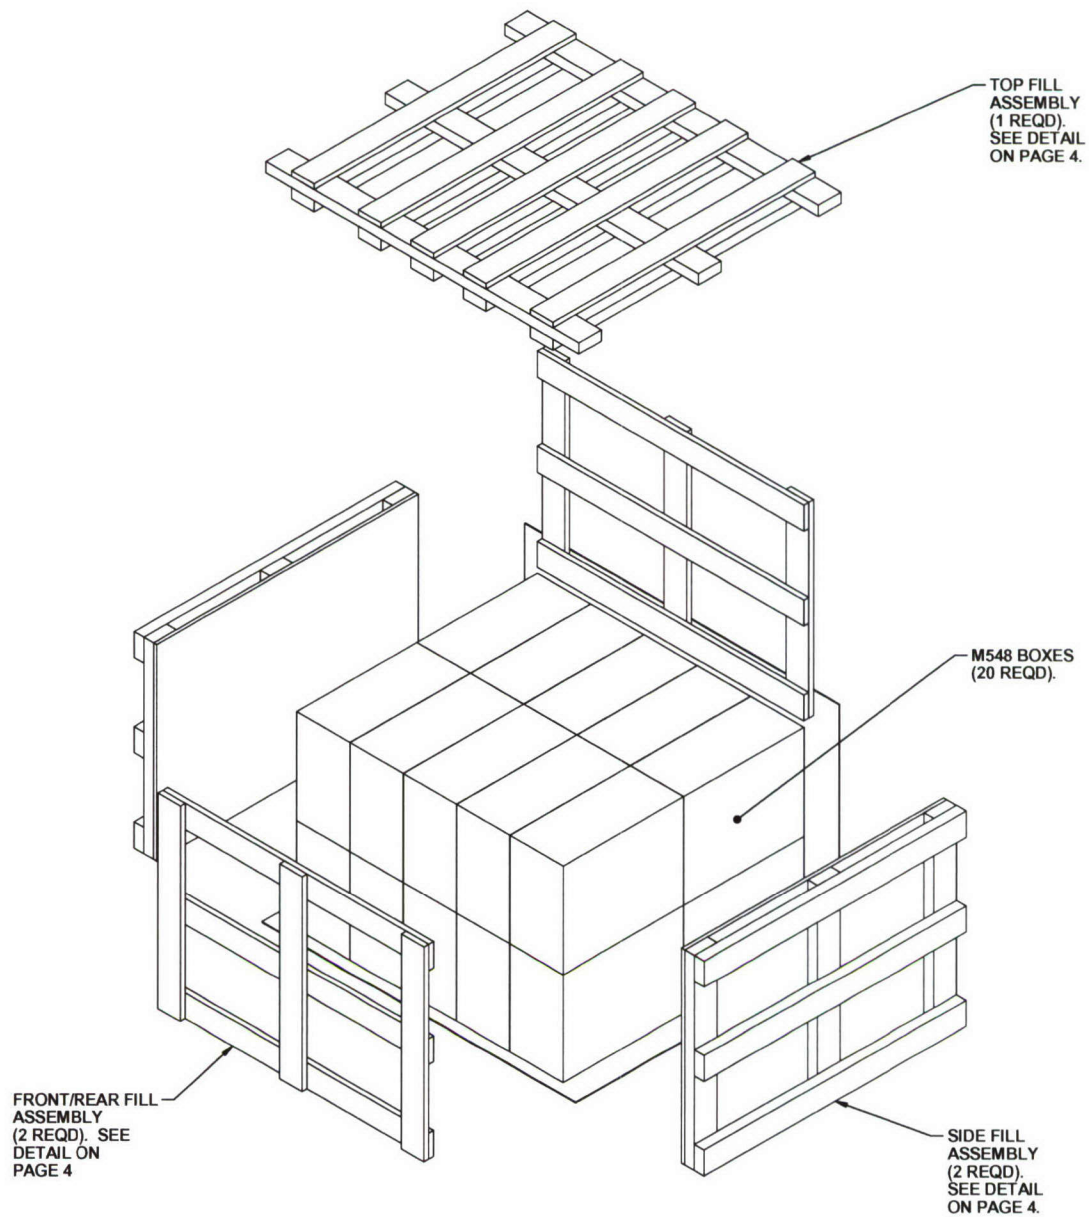
NAVY CLOSED PANEL JMIC UNIT

20 M548 BOXES @ 125 LBS	2,500 LBS
DUNNAGE	146 LBS
CLOSED PANEL NAVY JMIC	325 LBS

TOTAL WEIGHT	2,971 LBS (APPROX)
CUBE	56.4 CU FT (APPROX)

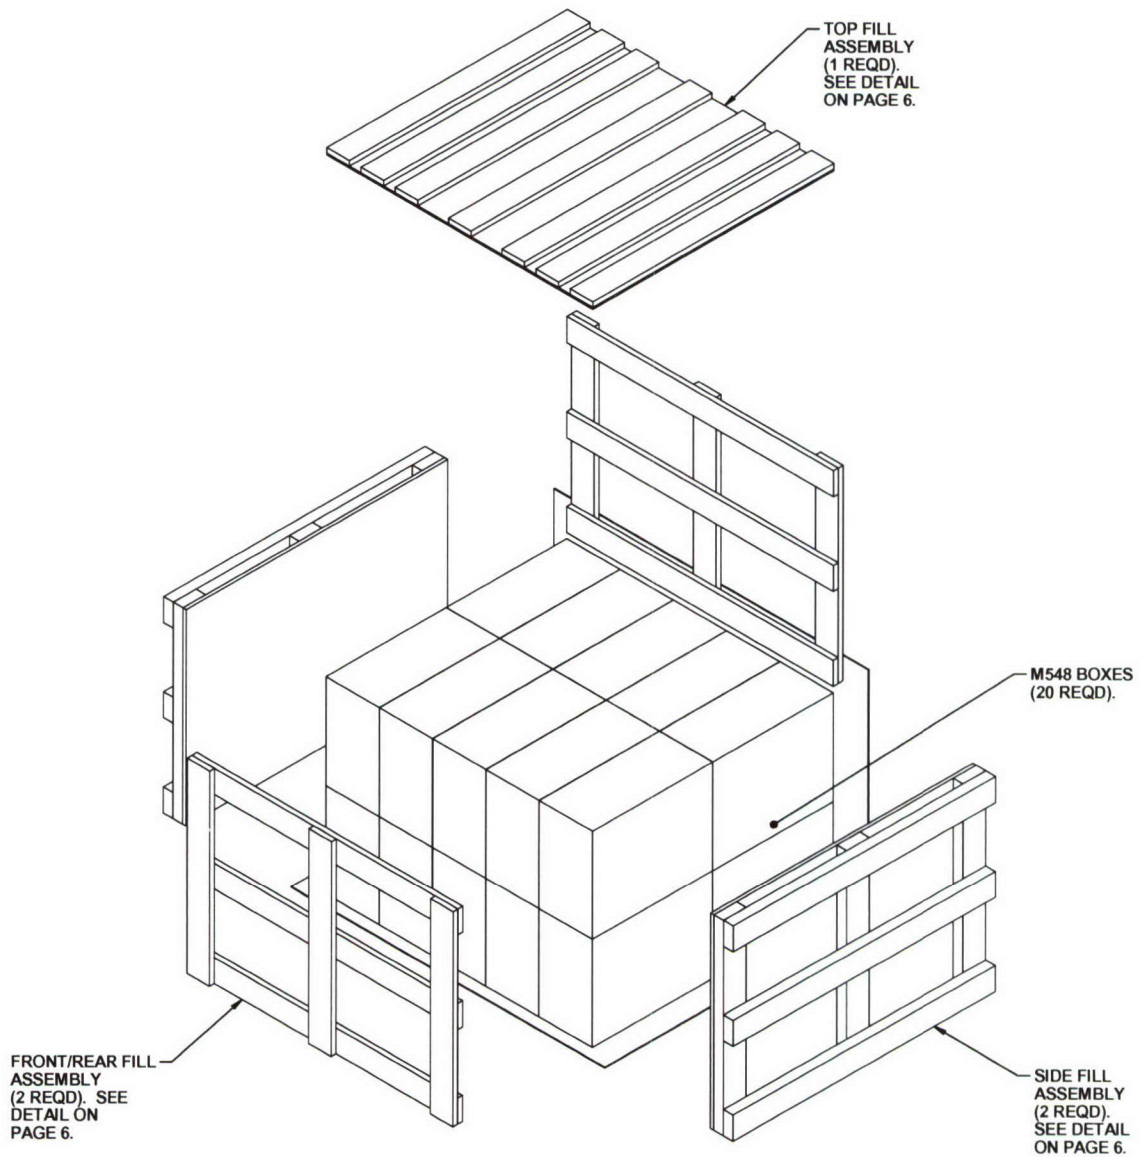
NAVY OPEN FRAME JMIC UNIT

STRAPPING NOT SHOWN. SEE STRAPPING DETAIL 1 & 2 ON PAGE 7 FOR FURTHER INFORMATION.

TOTAL WEIGHT	-----	2,912 LBS (APPROX)
CUBE	-----	56.4 CU FT (APPROX)

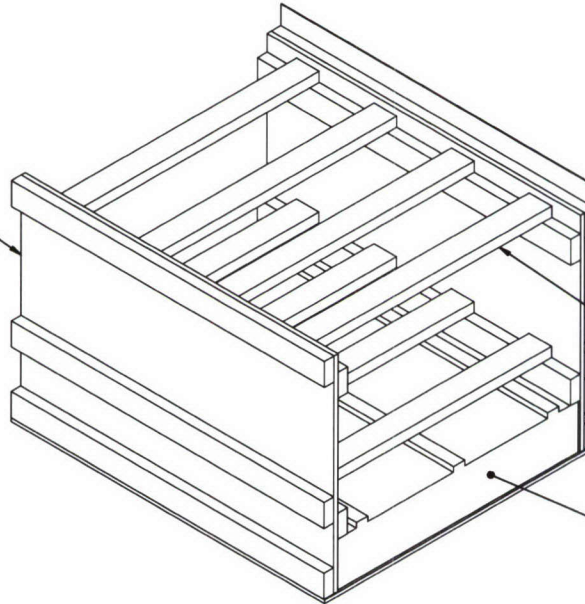
END FILL ASSEMBLIES
(2 REQD). SEE END
FILL ASSEMBLY A DETAIL
ON PAGE 8.

STRUTS, 2\" X 4\" X
CUT TO FIT (37-11/32 REF)
(8 REQD). NAIL TO LEDGE
PIECES ON END FILL
ASSEMBLIES W/2-10d NAILS
AT EACH JOINT.

C44S WOODEN BOXES
(4 REQD).

4 C44S BOXES @ 120 LBS	-----	480 LBS
DUNNAGE	-----	126 LBS
BAE JMIC	-----	310 LBS
<hr/>		
TOTAL WEIGHT	-----	916 LBS (APPROX)
CUBE	-----	56.7 CU FT (APPROX)

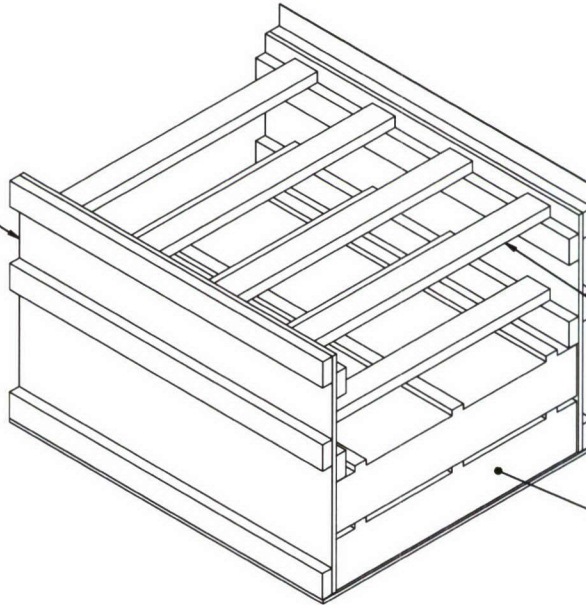
END FILL ASSEMBLIES
(2 REQD). SEE END
FILL ASSEMBLY B DETAIL
ON PAGE 10.

STRUTS, 2" X 4" X
CUT TO FIT (37-11/32 REF)
(8 REQD). NAIL TO LEDGE
PIECES ON END FILL
ASSEMBLIES W/2-10d NAILS
AT EACH JOINT.

C445 WOODEN BOXES
(8 REQD).
